Surface Scoring/Babbitting

Tech Help

Applications: Ford Probe, Contour/Mystique, Cougar
Mazda 626, 6, MX-3, MX-6

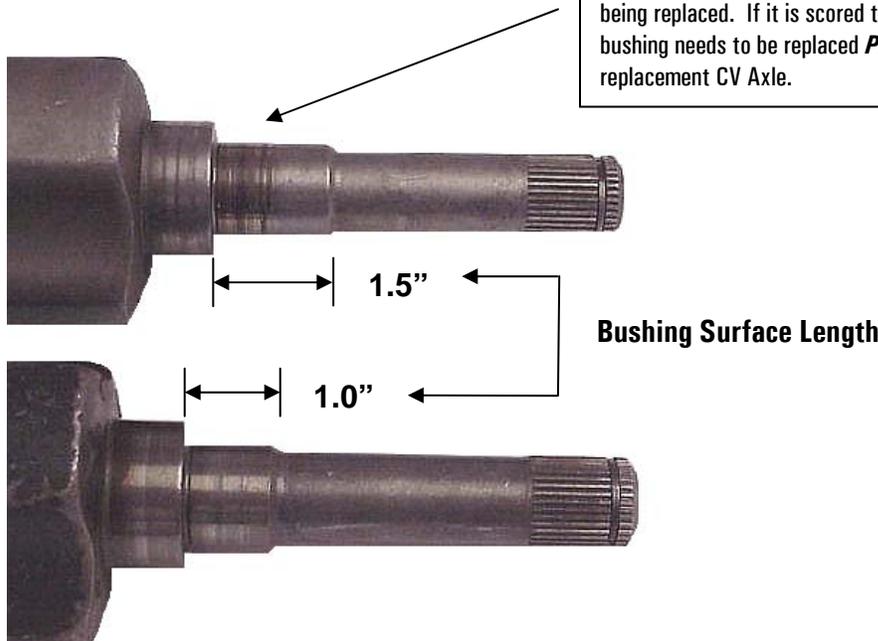
For the above listed applications the transmission support bushing is failing. If the bushing is not repaired **prior to installation** of the GSP CV [axle](#), it will result in the failure of the inboard joint. Failure in this area is not the fault of the axle. The transmission bushing wears and consequently wears out the surface of the inboard housing. There are two bushing surface lengths on the inboard housing: 1" and 1.5". Both styles will work for replacement. The illustration below notes the bushing surface length difference and an example of the surface scoring. Another indication that the transmission bushing has failed is if there is metal transfer on the axle when it is removed.

Example of Surface Scoring

Be aware that if there is scoring on the surface of the axle when removed or any metal transfer, the transmission bushing should be replaced before installation of the replacement CV axle. If the bushing is not replaced, it is likely that the transmission will leak and a vibration or knocking noise will be present. The most common causes of these bushing failures are worn front struts and/or a bad thrust angle alignment and/or worn motor/transaxle mounts.

WARNING – Check this bushing surface on the unit being replaced. If it is scored the transmission bushing needs to be replaced **PRIOR** to installing the replacement CV Axle.
