# SMITTYBILT TECHNICAL UPDATE

## TECHNICAL ISSUE

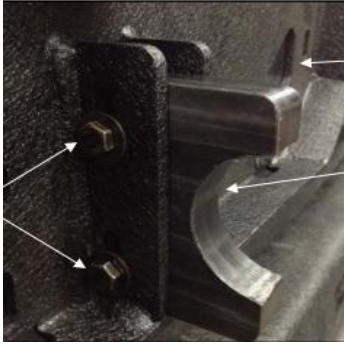
Fig A

Possible excessive movement or rattling (Gen 2 tire carrier) part# 76857. This could be caused by the heim joint being too long and incorrect heim joint bolts. The tire carrier must rest in the "C" bump stop properly to prevent movement. (Fig A,B)

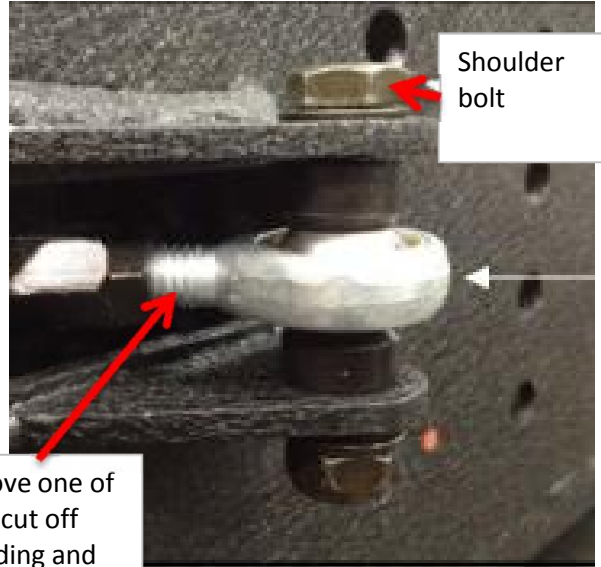
Fig C

Shoulder bolt

- A. You can remove one of the ends and cut off 1/4" of threading and re-insert. (Fig C)
- B. We will have inventory of the shorter Heim joint (Part # 76857-03) ETA 8/27 and more coming 9/4

You can remove one of the ends and cut off 1/4" of threading and
