00 Chrysler Voyager/Grand Voyager • 95-00 Chrysler Town & Country

NUMBER: 02-004-01

Knock/Squawk Sound From Front Suspension

knock/Clunk Sound From Front Strut Area

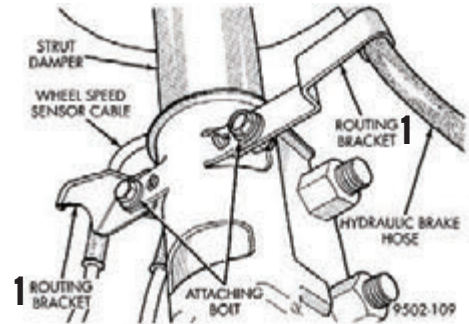
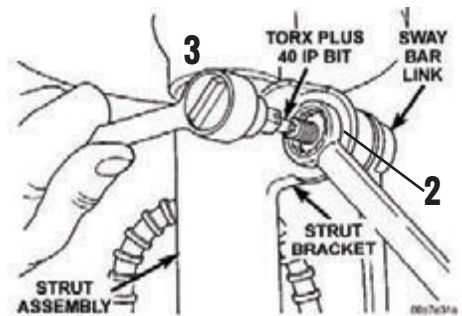
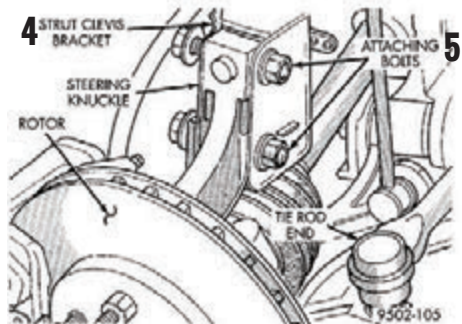
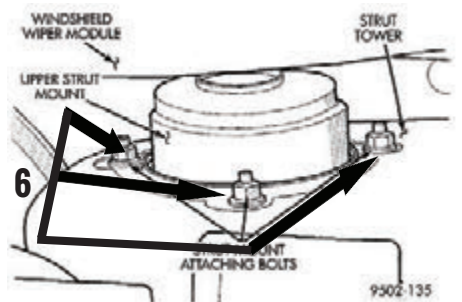
1. Loosen lug nuts on front wheels
2. Raise vehicle and support with suitable jack stands
3. Remove wheels
5. Remove the hydraulic brake hose routing bracket and the speed sensor cable routing bracket from the strut damper brackets (#1)
6. Remove the stabilizer bar attaching link from the bracket on the strut assembly. (#2)

! When removing nut from stud of stabilizer bar attaching link do not allow stud to rotate. Hold stud from rotating by inserting a Torx Plus 40IP bit in the end of the stud. (#3)

! The lower strut assembly attaching bolts (#5) are serrated and must not be turned during removal. Remove nuts while holding bolts stationary in the steering knuckles

7. Remove lower strut mounting bolts (#4)

8. Remove upper strut mounting nuts (#6)
9. **Remove strut assembly from vehicle**
