**NEW-BUILD,
HIGH-PERFORMANCE
ABS MODULES**

OE FIX EXPLAINED

WHAT'S AN OE FIX?

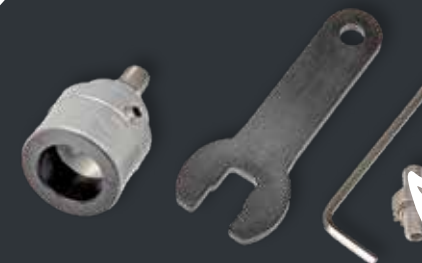
Radio Antenna Base Repair Kit

Includes programmer tool to prevent additional trip to dealership

Eliminates need to route new antenna and cable through dashboard

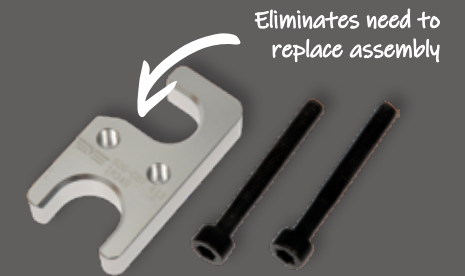
Park Position Switch

Eliminates need to replace assembly

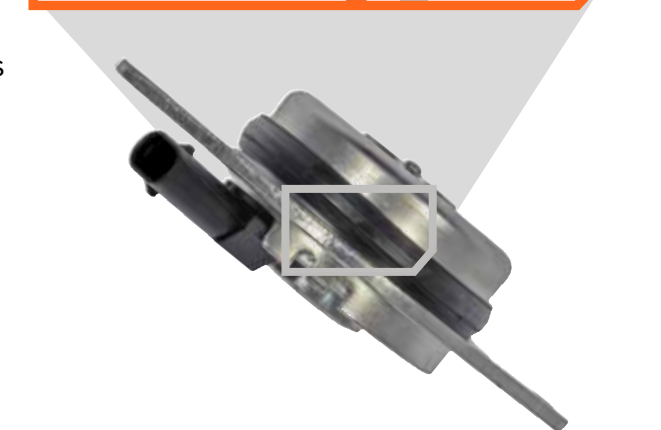
Engine Variable Valve Timing (VVT) Solenoid 916-886XD: Select General Motors work vans, pick-ups, SUVs and cars 2017-06, Isuzu NPR 2016-08

Dorman's engineers found that the original equipment VVT on more than 5.5 million GM and Isuzu vehicles with certain V8 engines – everything from Suburban and Silverado to Express and Hummer – may fail prematurely due to a weak stationary tube. If the tube wears out, excessive internal movement can occur, causing internal leaking and a loss of oil pressure.

Our engineering analysis led to a new design that incorporates a durable brass tube. We also increased the oil flow through the part with additional oil passages. And, as a bonus, we added the hard-to-source gasket, and included it in the installation hardware kit to help provide a reliable repair.

1 of 8 VVTs with patented or patent-pending designs

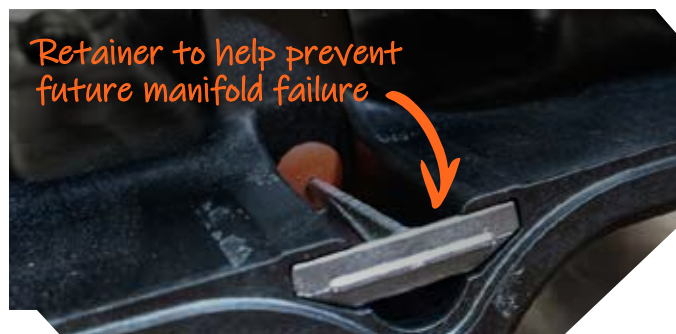
Intake Manifold and Valve Cover Kit 615-380KIT: 1.4L Ecotec engine, Buick Encore 2019-13, Chevrolet Cruze, Sonic, Trax 2019-13

What happens is the tiny umbrella valve in the manifold may dislodge over time, drop out of its mount, then get sucked into the intake and combusted. When it's gone, vaporized oil is free to pass through the system, resulting in higher oil consumption, and excessive vacuum that can destroy the fragile diaphragm integrated into the valve cover's PCV cap.

Dorman's OE FIX intake manifold (**615-380**) takes care of the inherent problem in the original manifold design by incorporating a T-shaped

retainer that locks the valve in position, to help ensure it can't break free.

Since the manifold and valve cover (**264-968**) often need to be replaced together, along with the breather tube (**46829**) that connects them, we make them available separately as well as package them together (**615-380KIT**) to help you ensure all failure points are addressed right the first time.

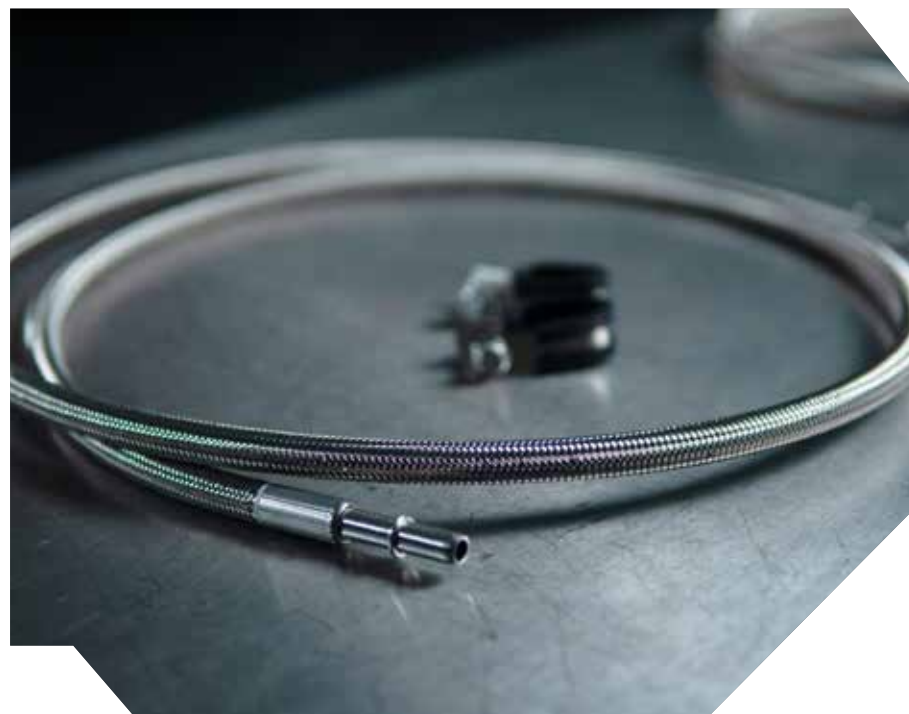
Fuel Lines 819-816, 819-846, 819-876: Standard, Extended and Crew Cab Chevrolet Silverado and GMC Sierra Pickups 2010-04

Dorman's new OE FIX flexible fuel lines are made of pliable PTFE tubing covered with braided stainless steel that can easily be routed through difficult chassis and body passages, reducing the need to remove any major components for a faster,

easier installation. Each set is manufactured to the exact length required for the vehicle and includes pre-installed, factory-style fittings for a leak-free connection.

In addition to being easier to install, these flexible fuel lines are more durable than many factory-style steel lines. The PTFE tubing will not rust – from either the inside or the outside – and the protective braided sheathing is made from corrosion-resistant stainless steel for abrasion resistance.

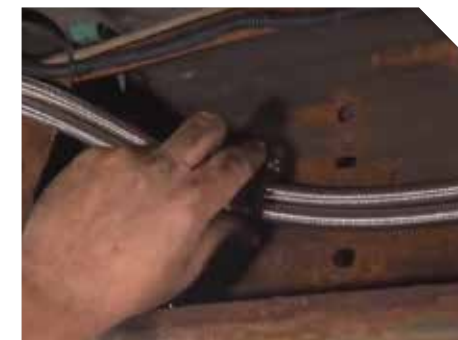
With the old fuel lines removed, route the new lines through the original path on the body and frame, starting at the fuel tank.

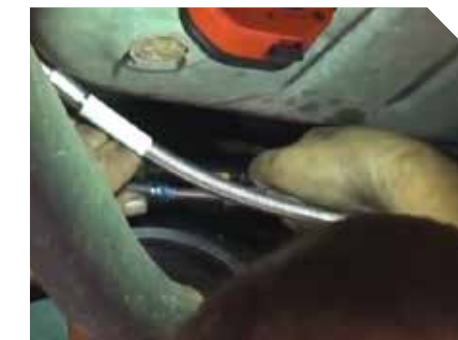
Connect the new fuel lines at the fuel tank and engine to ensure everything is properly located.

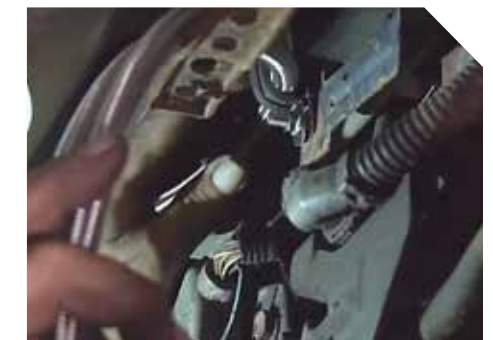
Using the supplied hardware, install new mounting brackets in the same positions as the original mounts.

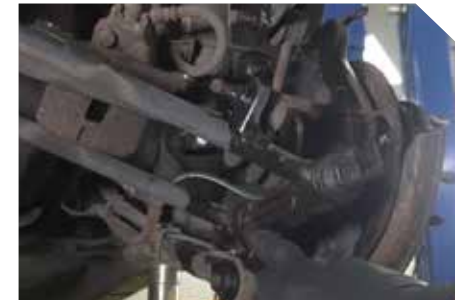
Step 1
Use penetrating solvent to soak all hardware.

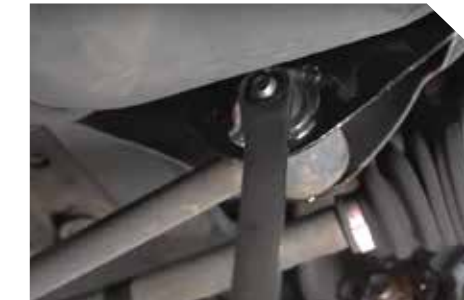
Step 2
Disconnect the lateral control arms at the rear subframe.

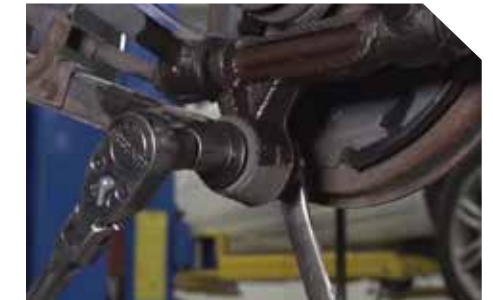
Step 3
Disconnect the trailing arm, brake hardware and sway bar from suspension knuckle.

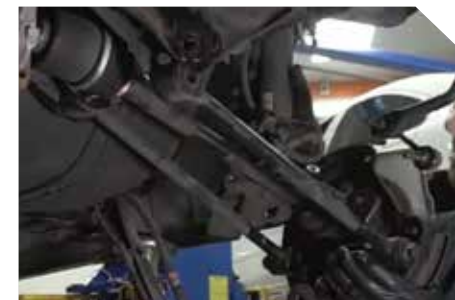
Step 4
Disconnect the strut mount at the knuckle and remove the axle assembly as a unit.

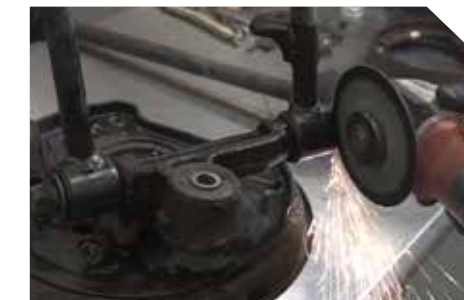
Step 5
Cut the nut off the through-bolt and remove the old bushings.

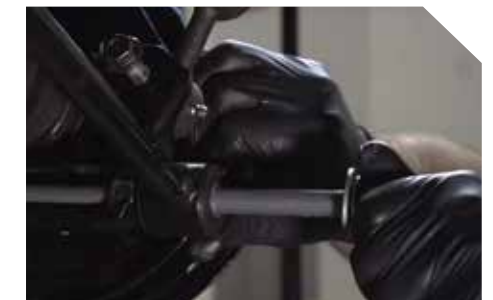
Step 6
Install new lateral link bushings, install the new loaded knuckle, and reassemble using the new through-bolt.

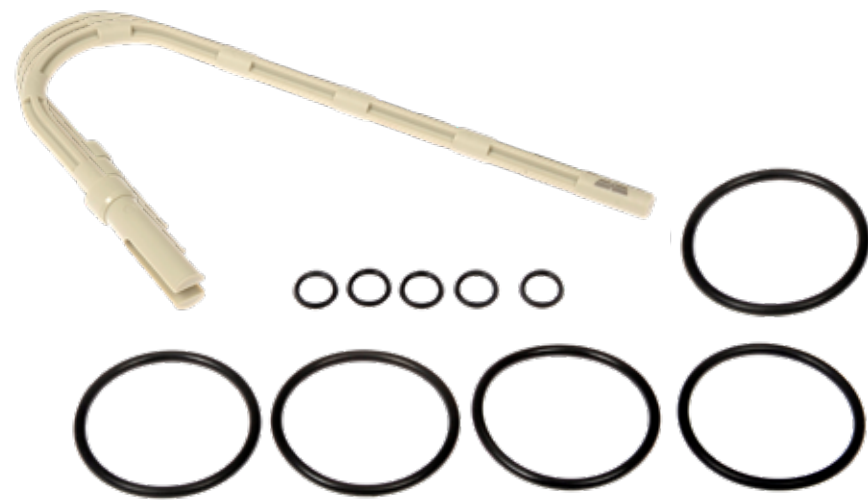
Engine Oil Dipstick Flange Repair Kit 904-423: Ford 2003-94, IC Corporation 2004-02, International 2004-94

Vehicles equipped with Ford's 7.3L Power Stroke diesel V8 engines have an O-ring between the oil pan and the dipstick mounting flange that eventually may deteriorate, causing leaks. Because the dipstick flange is installed from inside the oil pan, replacing this basic seal may lead to hours of labor to remove the oil pan for access.

Dorman's OE FIX dipstick flange repair kit includes new O-rings, including pan-to-flange and flange-to-tube, plus our exclusive tool that allows the flange to be resealed in place, without having to remove the oil pan. Developed with technicians in mind, each kit contains enough pieces for five complete repairs.

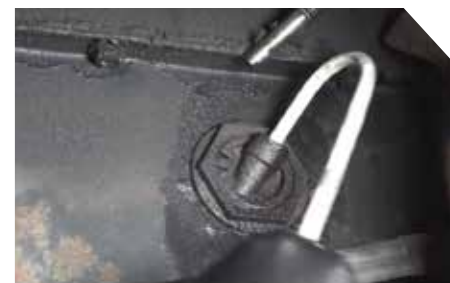
Step 1
Insert flange rod.

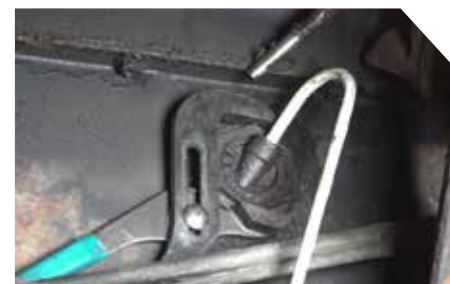
Step 2
Loosen dipstick flange.

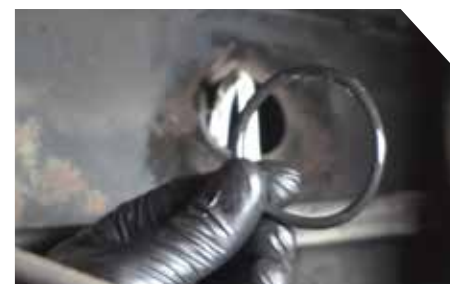
Step 3
Remove old seal with hook.

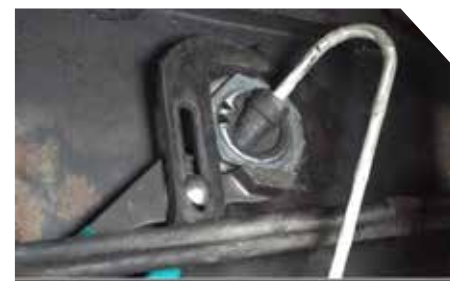
Step 4
Secure dipstick flange nut.

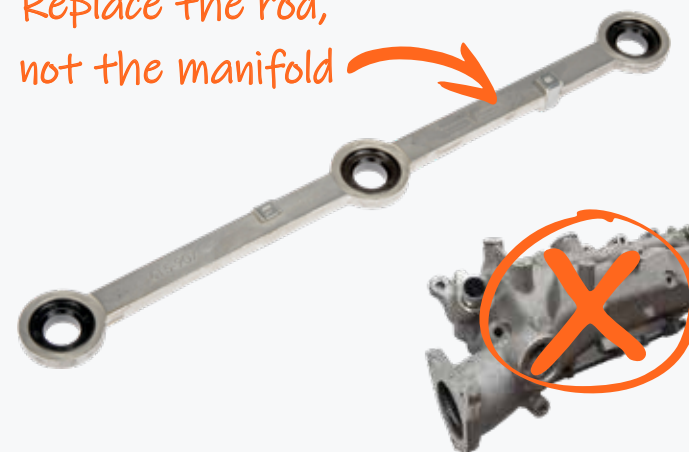
Intake Manifold Runner Control Connecting Rod

When the plastic intake manifold runner control (IMRC) connecting rods break, they cause rough running and an engine light. The original manufacturer doesn't offer replacement connecting rods alone, requiring you to replace the entire intake manifold to make a simple repair.

Dorman's OE FIX upgrades the IMRC connecting rod material to aluminum for enhanced durability and makes them available individually, saving significant money compared to purchasing a new intake manifold.

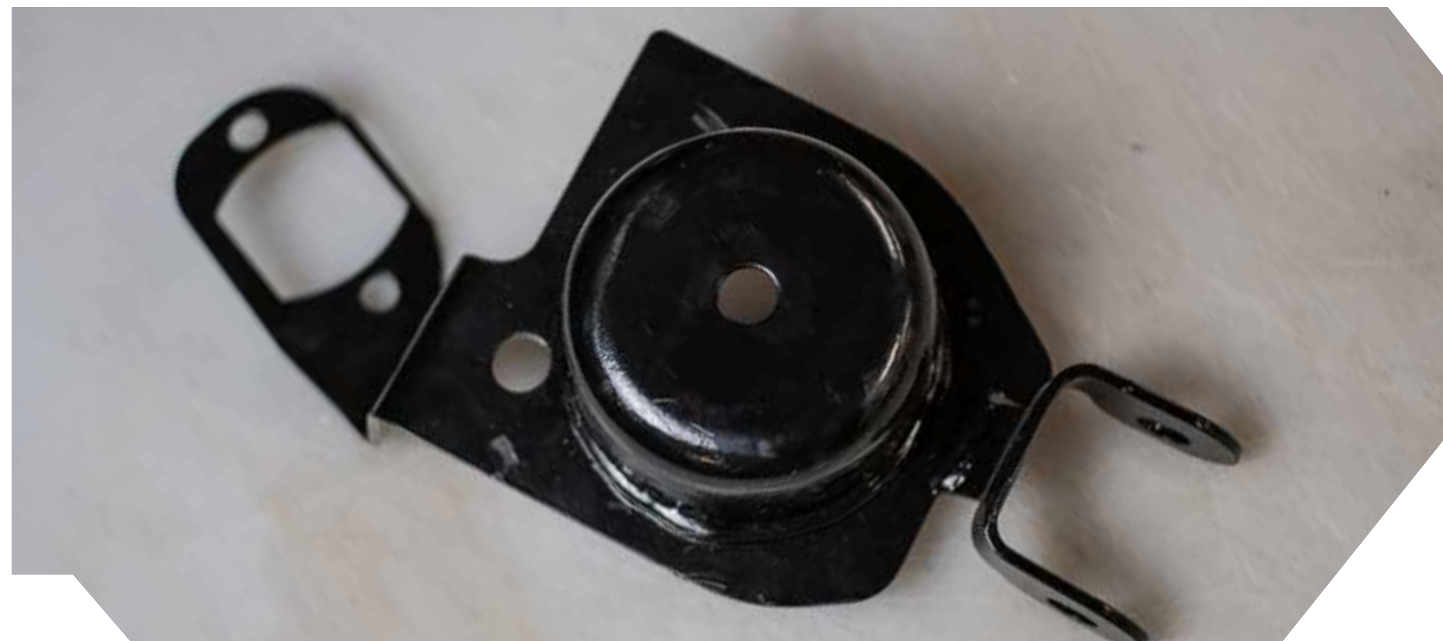
Suspension - Coil Spring Seat Repair Kit 926-078 (Front Lower Right), 926-079 (Front Lower Left): Jeep Grand Cherokee 2004-99

Front axle coil spring mounts are prime targets for corrosion, and failure could lead to a dangerous loss of control. If they're looking rusty, you don't want to wait for them to give out.

Dorman created OE FIX coil spring mounts to directly replace corroded factory perches, while retaining the original axle on 2004-99 Grand Cherokee models.

Made of stamped steel, these brackets bolt into place on the axle after the original spring mounts are cut or ground off, potentially saving hours of labor compared to replacing the axle or fabricating new parts.

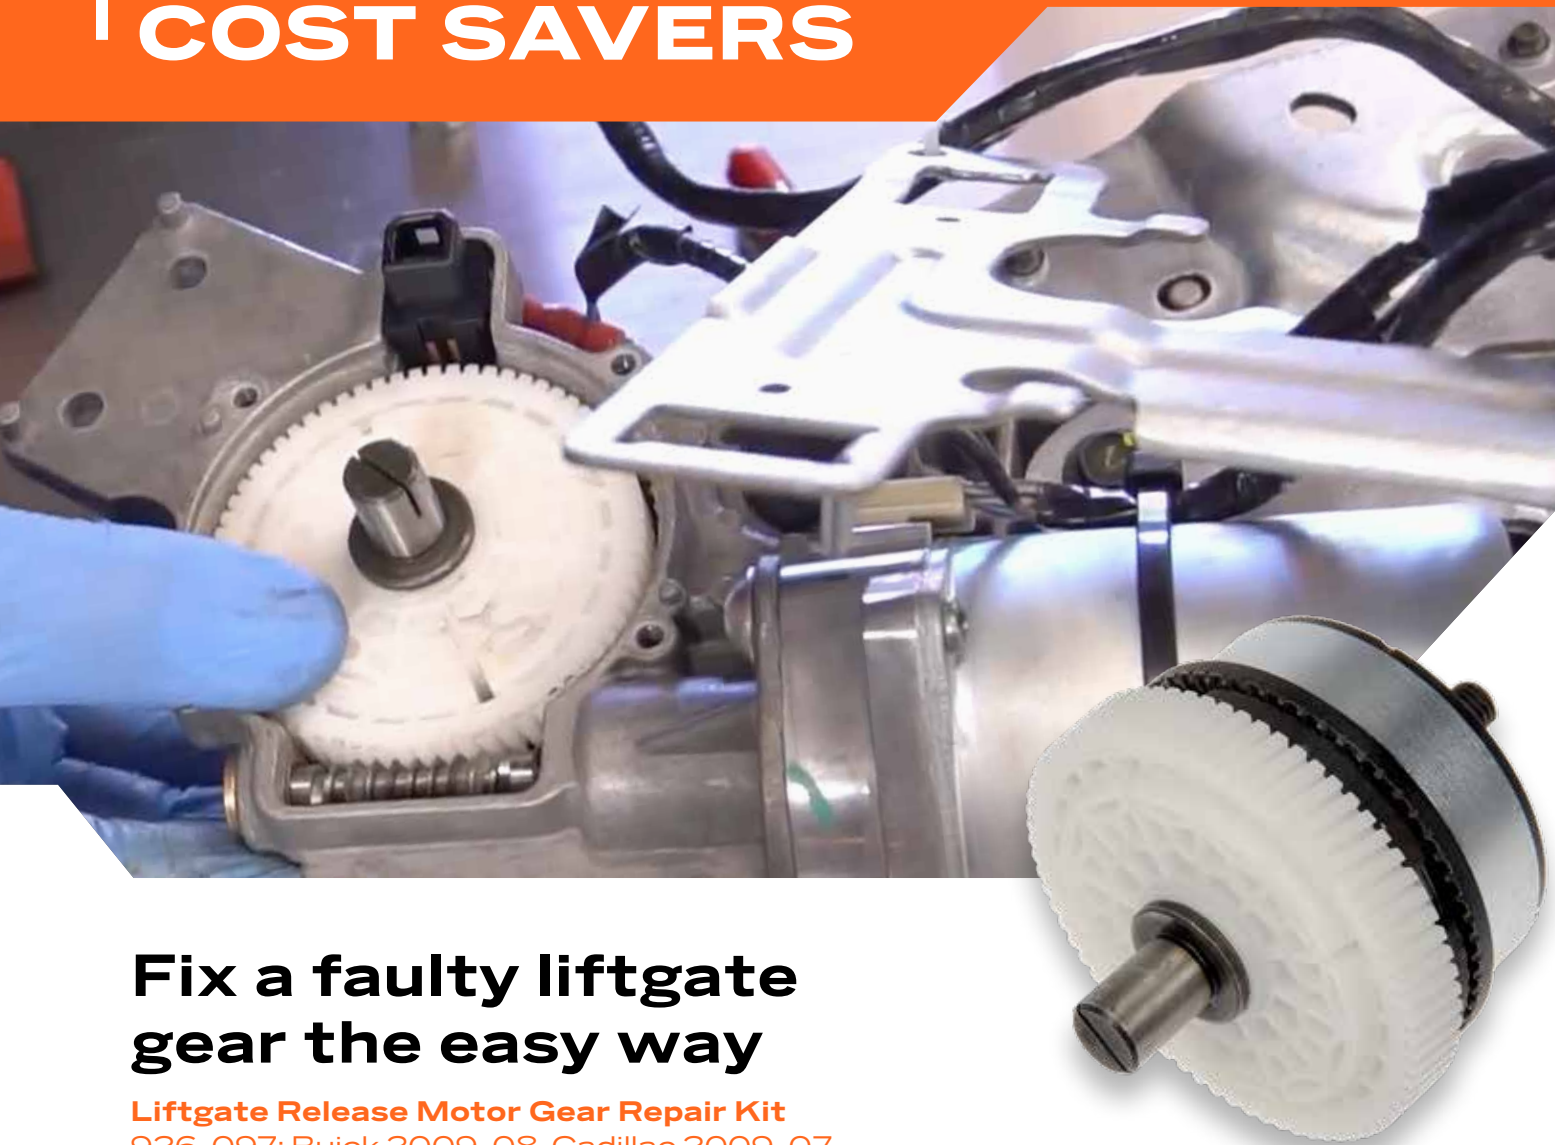
Liftgate Release Motor Gear Repair Kit
926-097: Buick 2009-08, Cadillac 2009-07,
Chevrolet 2009-07, GMC 2009-07, Saturn 2009-07

The powered liftgate on many General Motors SUVs may start making a terrible sound, and stop working, if the plastic teeth of the drive gear wear out over time.

Dorman's OE FIX liftgate release motor gear kit is a cost-effective way to solve this problem. Made of durable plastic to factory dimensions, the replacement gear assembly mates to the original drive motor, making the liftgate work properly again, and making both the installer and vehicle owner happy.
