CARDONE ProTech

Grounding Wiper Motor Corrects Parking and Other Problems

Protecting GM Wiper Motors from Water Intrusion

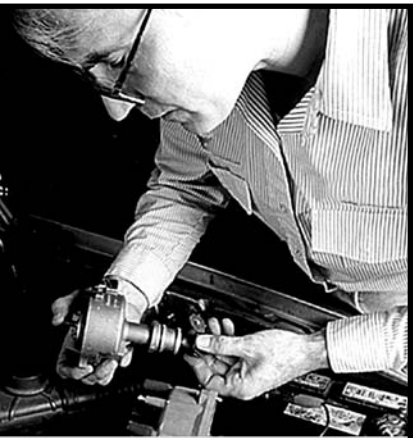
Wiper motors with and without integrated electronic pulse board not working properly or at all.

Wiper motor and/or electronic components may have failed due to water intrusion.

To protect the replacement wiper motor and pulse board, be sure water does not drain on wiper motor assembly. Remove any debris that might block or restrict the flow of drain water to the left or right fender well areas. Be sure to also check for proper operation of control switch and associated wiring.

To prevent water intrusion, our replacement units are re-engineered to overcome original design flaws. Vent holes that allow water entry are blocked, therefore protecting the motor & its electronic components.
