## Brake Rotor Installation Tips

**To assure pulsation free performance over the life of your brakes**

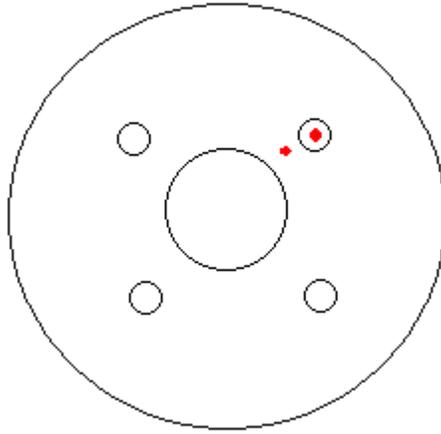
- Confirm that the hub and rotor mating surfaces are clean and free of any rust, dust, or other debris, install the rotor onto the hub, and mark the initial position with a paint mark on a lug stud and next to the corresponding lug hole.

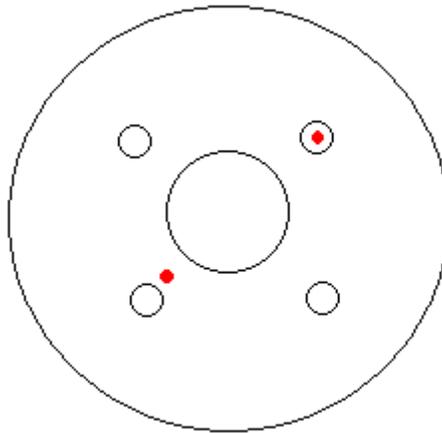
- Next, remove the rotor and install in a different position on the hub:

Measure runout and record results once again. If the results from both measurements match in both location and amount of runout measured, then excessive runout exists in the rotor itself, and the rotor requires either replacement or machining.
