TECH TIPS

Let's get the rust out

By Phil Pollick,
ATE Product Manager,
Continental Corporation

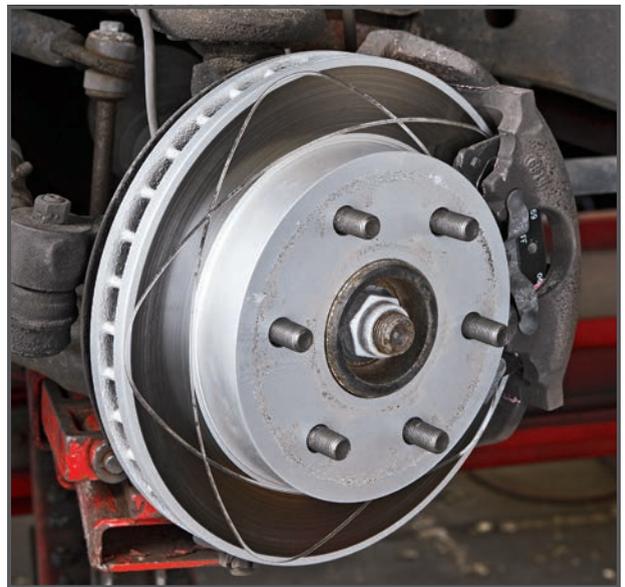
Although this vehicle has been on the road for a while, the MetaCote finish on the ATE PremiumOne rotor has prevented any new rust from developing on the rotor.

To avoid the extra step of cleaning the [rotor](#) before installation and prevent future corrosion, it would be best to use a rotor that has been pre-treated with a protective coating, such as the ATE PremiumOne rotor. The ATE rotor features a MetaCote finish that helps prevent rust and corrosion and sheds water and dirt to maintain a clean appearance.
