## Troubleshooting Disc Brakes: Rotors Don't Cause Most Rotor Problems

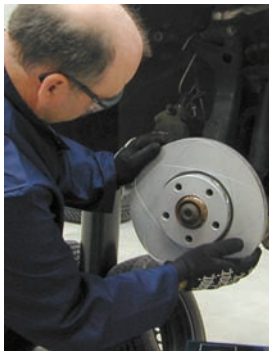
### **Problem:** Cracked pot/hat

**Visible clues:** Disc pot cracked near a wheel bolt.  
**Possible cause:** Bolt(s) improperly press-fitted.  
**Solution:** Press-fit bolts in accordance with manufacturer's data.
