Installation Instructions for 99-8300

Toyota Multi-kit 2000-up

99-8300

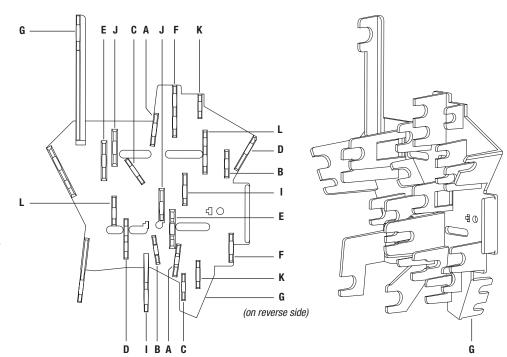
Bracket #1 tab layout (Drivers side shown)

Bracket #	Tab	Vehicle	
1	Α	Scion xB	2008-up
1	В	Scion FR-S, Subaru BRZ	2013-up
1	С	Scion xB	2004-2007
1	D	Scion xA	2004-2006
1	Е	Toyota Yaris	2012-up
1	F	Scion tC	2011-up
1	G	Scion tC	2005-2010
1	Ι	Toyota FJ	2007-up
1	J	Toyota Corolla	2009-up
1	K	Toyota MR2 Spyder	2000-2005
1	L	Toyota RAV 4	2001-2005

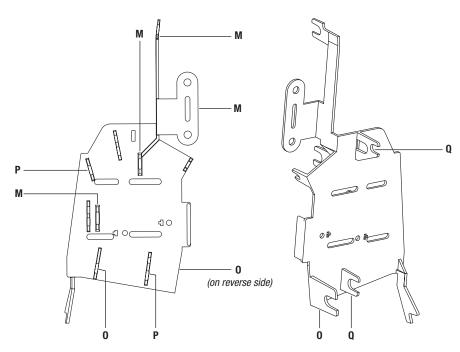
Bracket #2 tab layout

Bracket #	Tab	Vehicle		
2	M	Toyota Highlander	2001-2007	
2	0	Toyota 4 Runner (excluding Limited)	2003-2009	
2	Р	Scion xD	2008-up	
2	Q	Toyota Celica	2000-2005

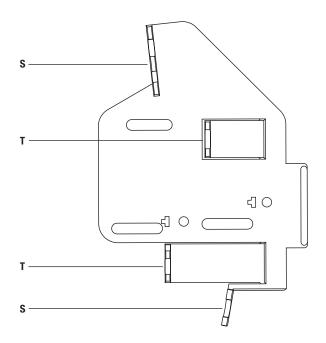
Bracket #3 tab layout

Bracket #	Tab	Vehicle		
3	S	Toyota Yaris (3-door)	2007-2010	
3	Т	Toyota Sequoia	2003-2007	
3	Т	Toyota Tundra	2003-2006

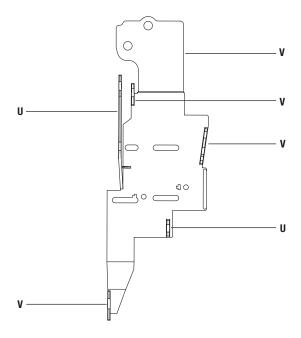
Bracket #4 tab layout

Bracket #	Tab	Vehicle		
4	U	Toyota Yaris (4-door)	2007-2010	
4	V	Toyota Highlander	2013

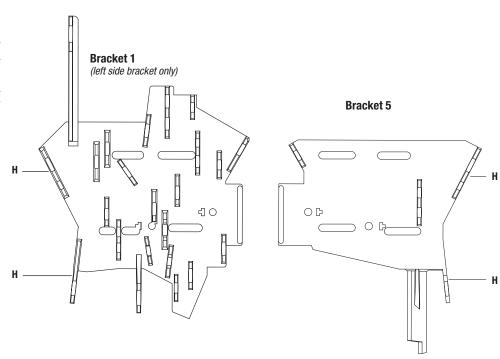
Brackets #1 and #5 tab layout (Scion iQ, 2012-up)

Bracket #	Tab	Vehi	cle
1 (left side bracket only)	Н	Scion iQ	2012-up
5	Н	SCIUII IQ	2012-up

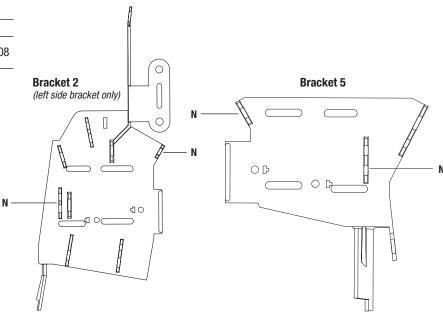
Brackets #2 and #5 tab layout (Toyota Matrix, Pontiac Vibe, 2003-2008)

Bracket #	Tab	Vehicle		
2 (left side bracket only)	N Toyota Matrix, Pontiac Vibe 2003-200			
5	N	- Toyota Matrix, Fortulac Vide 2005-20

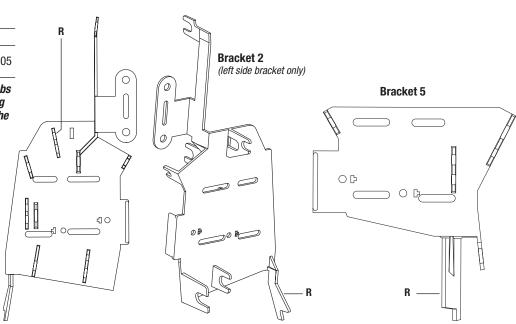
Brackets #2 and #5 tab layout (Toyota Echo, 2000-2005)

Bracket #	Tab	Vehicle
2 (left side bracket only)	R	Toyota Echo 2000-2005
5	R	10y0ta L6110 2000-2005
