SPICER LIFE SERIES™
SERVICE MANUAL
SECTION 2
3264-SPL
MARCH 1998

55, 70, 90, 100, 140, 170 & 250

SPICER LIFE SERIES™ FEATURES & BENEFITS

This manual encompasses inspection, lubrication, removal and installation procedures for Spicer Life Series™ 55, 70, 90, 100, 140, 170 and 250 driveshaft assemblies.

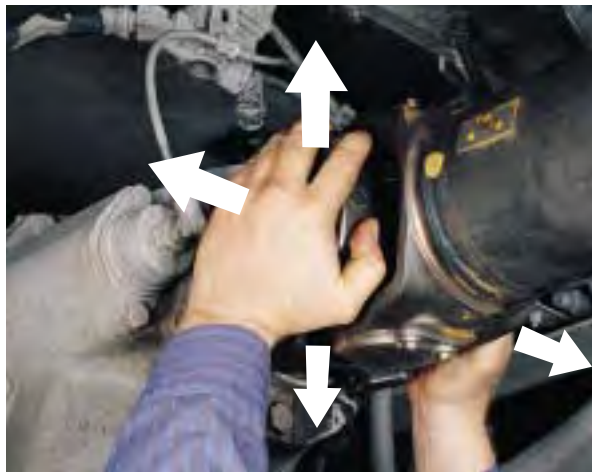
Photo 1

2. Check all input and output end fittings for looseness or broken back. Take hold of the end fitting with both hands. Try to move it vertically and horizontally to feel any looseness. (See photo 1, above.)

A loose end-fitting retaining nut or bolt can result in

driveline failure, which can result in separation of the driveline from the vehicle. A separated driveline can result in property damage, serious personal injury or death.

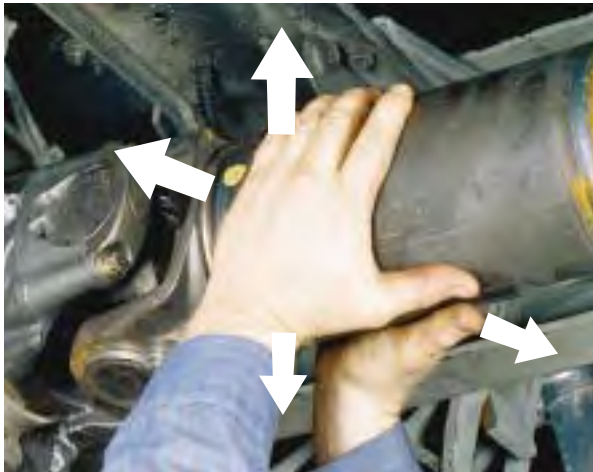
Photo 3

5. Check for excessive looseness across the ends of the universal joint bearing cup assemblies and trunnions. Take hold of the inboard yoke on the driveshaft with both hands. Try to move yoke vertically and horizontally. (See photo 3, above.)

There should be less than .006 in. (.15mm) movement in the universal joint kit relative to the inboard or outboard yokes. If looseness is greater than .006 in. (.15mm), the universal joint kit must be replaced. ▲ See warning, below.

Excessive looseness across ends of universal joint bearing cup assemblies can cause imbalance or vibration in the driveshaft assembly. Imbalance or vibration can cause component wear, which can result in separation of the driveline from the vehicle. A separated driveline can result in property damage, serious personal injury or death.

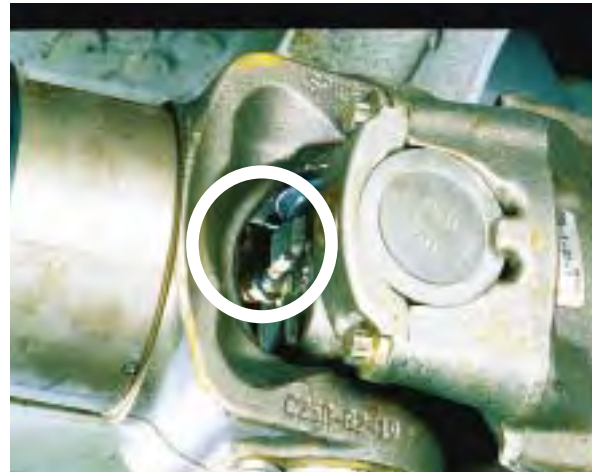
Photo 4, Relubable Style

7. Check for the presence of all grease zerk (nipple) fittings. (See photo 4, above). Grease zerk (nipple) fittings should not be missing, loose or fractured. ▲ See warning, below.

A missing, loose or fractured grease zerk (nipple) fitting eliminates the ability to relubricate the universal joint. Neglecting to properly relubricate or inadequate lubrication can cause driveline failure, which can result in separation of the driveline from the vehicle. A separated driveline can result in property damage, serious personal injury or death.

If grease zerk (nipple) fitting is loose, tighten to required specifications. (See Table B, below.)

If grease zerk (nipple) fitting is fractured, replace grease zerk (nipple) fitting and tighten to required specifications. (See Table B, below.)

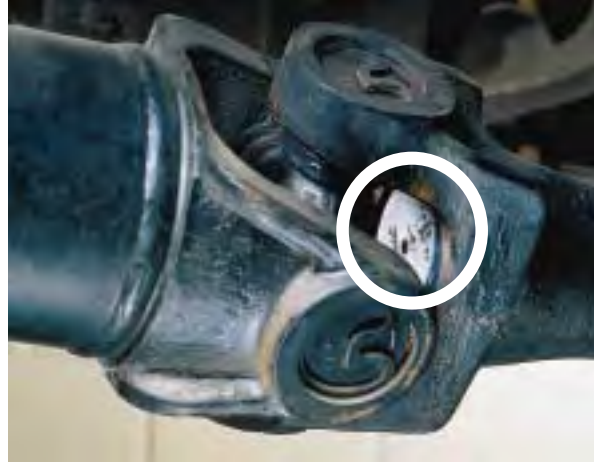
Photo 8

11. For an inboard and outboard slip yoke assembly design, check to be sure the slip yoke welch plug is not loose, missing or damaged. (See photo 8, above.) ▲ See warning, below.

If any of these situations are evident, replacement of the slip yoke and professional rebalancing of the driveshaft is necessary. Refer to the removal and installation sections of this manual for proper replacement procedures for slip members.

A loose, missing or damaged welch plug allows contaminants to invade the slip member assembly. Invasion of contaminants into the slip member assembly can degrade the lubricant and cause slip member component damage, which can result in separation of the driveline from the vehicle. A separated driveline can result in property damage, serious personal injury or death.

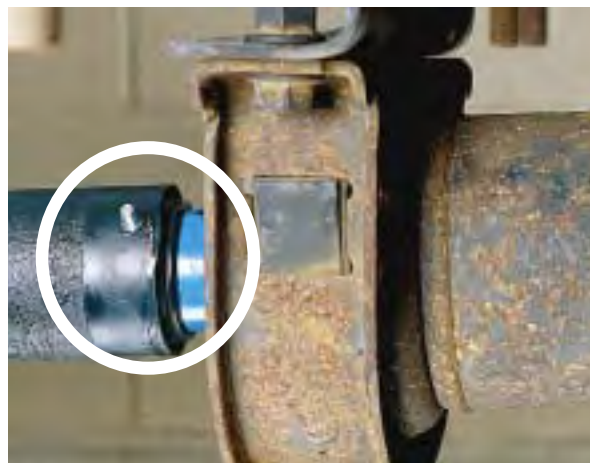
Photo 10

13. Check the slip yoke seal. (See photo 10, above.) Make sure the seal is properly attached to the slip yoke and is not loose or damaged. ▲ See warning, below.

If any of these situations are evident, replacement of slip member assembly is necessary. Refer to the removal and installation sections of this manual for proper replacement procedures for slip members.

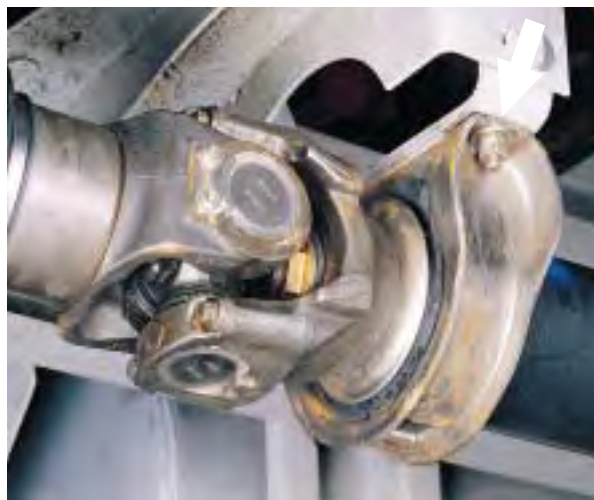
Photo 13

18. Inspect the center bearing bracket bolts for looseness. (See photo 13, below.) ▲ See warning, below.

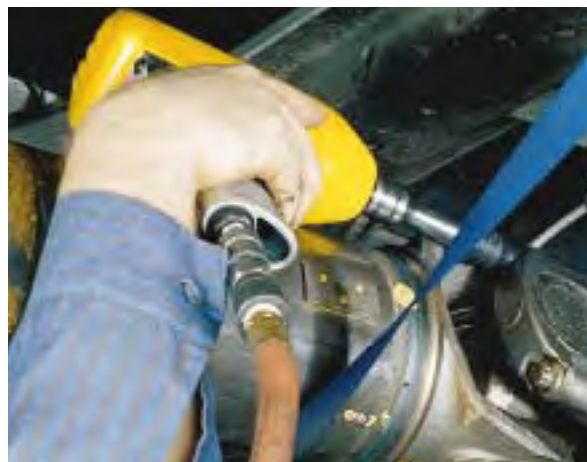
Photo 15

5. Remove the bearing retainers and bolts at the effected universal joint. Reference bolt specifications, Table H, page 28. (See photo 15, below.) Bearing retainer bolts with nylon lock patch **CANNOT** be reused. Loosening or removing bearing retainer bolts requires replacement of used bolts with new. ▲ See warning, below.

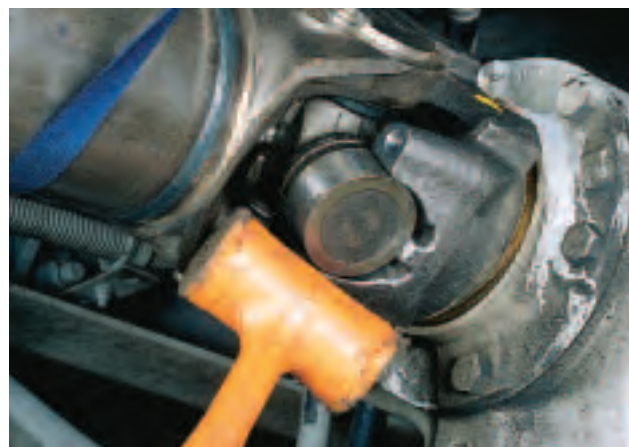
Photo 55

4. It may be necessary to unseat bearing cup assemblies, pilot or serrated connection by tapping on tube yoke or bearing cup with a soft-faced hammer. (See photo 55, below.) Once the bearing cup assemblies or connections are free, collapse the driveshaft until both bearing cup assemblies clear the open cross holes or flange yoke pilot is disconnected. Allow the driveshaft to rest on support strap.

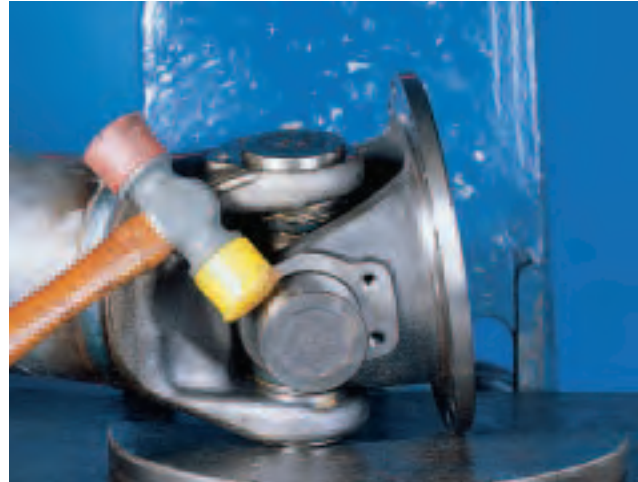
Photo 59, Companion Flange Style

17. Bearing cup is not designed to drop out of flange yoke. It will be necessary to use a soft-faced hammer to tap the partially pressed-out bearing cup from side to side, to “walk” the bearing cup out of flange yoke ear. (See photo 59, top right.)

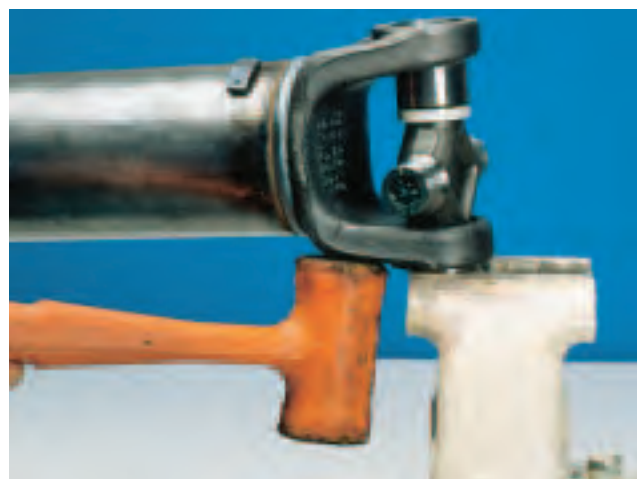
Photo 74

23. Grip the bearing cup in bench vice. (See photo 74, below.) Strike the yoke ear with a soft-faced hammer until bearing is removed.

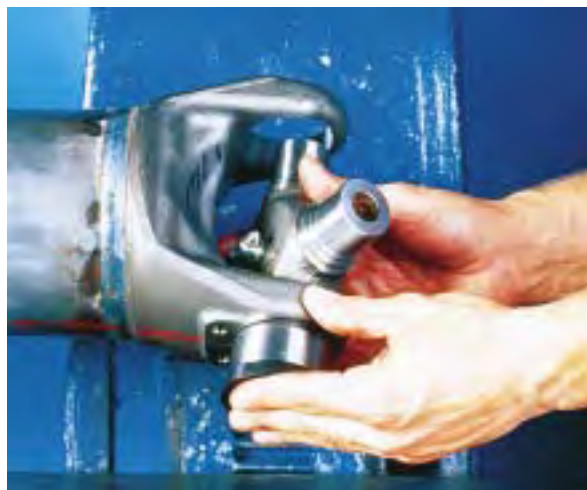
Photo 114

3. Move one end of the journal cross to cause a trunnion to project through the cross hole beyond the outer machined face of the yoke ear. Take one bearing cup assembly and position an installation height tool on the end of a bearing cup. Place the bearing cup assembly over the protruding trunnion diameter and align it to yoke cross hole. (See photo 114, top right.)
